TCO CASE STUDY

PULP AND PAPER INDUSTRY

IPS Engineering Solutions Reduce Equipment Failure and Downtime

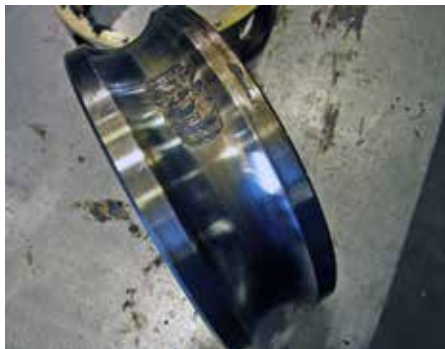
The difficult angle of the application lead to premature bearing failure.

IPS determined that the ball bearing on the drive end of the motor was failing due to the difficult angle of the application. The motor was connected to a Cardan U-jointed jackshaft; this angle didn't allow the U-joint to move easily to accommodate thermal expansion of the jackshaft, leading to moderate axial thrust on the drive end ball bearing and causing repeated failures. IPS modified the drive end bearing housing to accept a double row spherical roller bearing, which has nearly double the capacity of the standard ball bearing. The grease inlet and outlet paths were also modified to allow the bearing to properly re-lubricate.

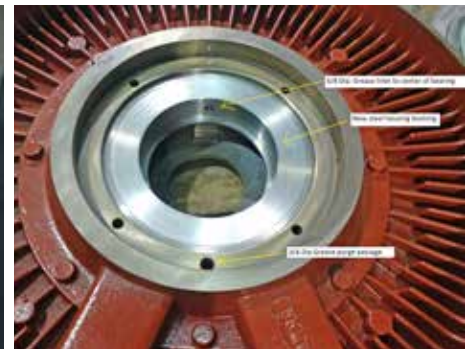
The modified grease inlets and outlets allow the redesigned bearings to properly re-lubricate.
